Forest Service  
Pacific  
Northwest  
Region

# Fish Creek

## Adaptive Watershed Management in the 21st Century

### *A Case Study*

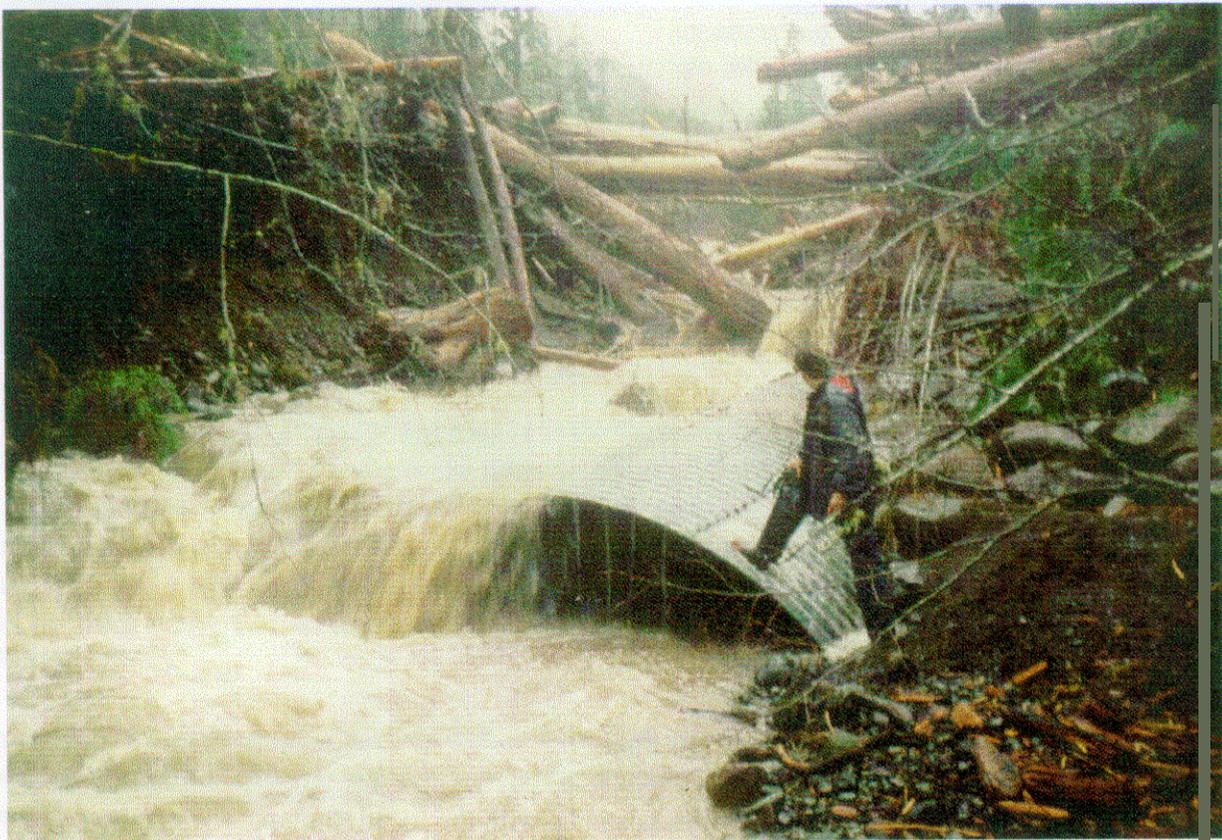
*A three-mile long debris torrent swept through Third Creek, a tributary to Fish Creek, and washed out the main road paralleling Fish Creek during the winter of 1995-96.*

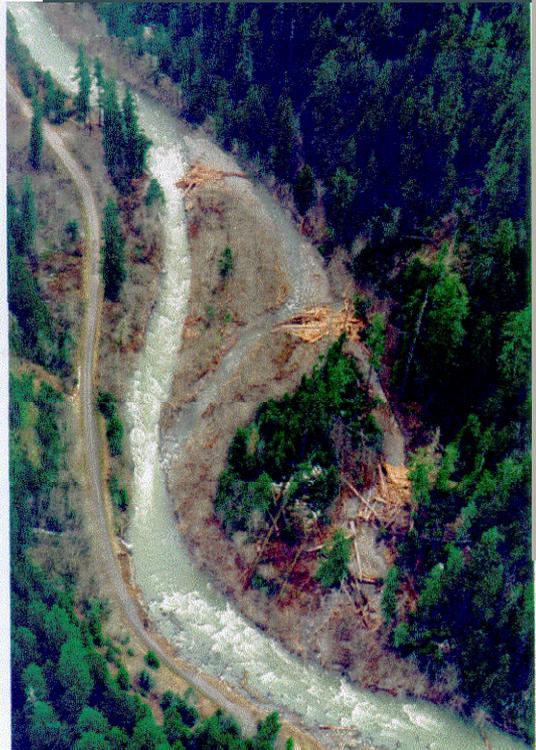
*Wood and gravel deposited by the floods changed fish habitat. Notice in the lower left corner Fish Creek is eroding the mud and reclaiming the natural stream channel.*

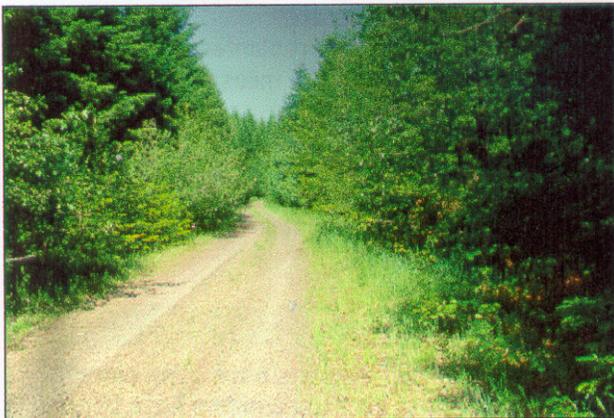
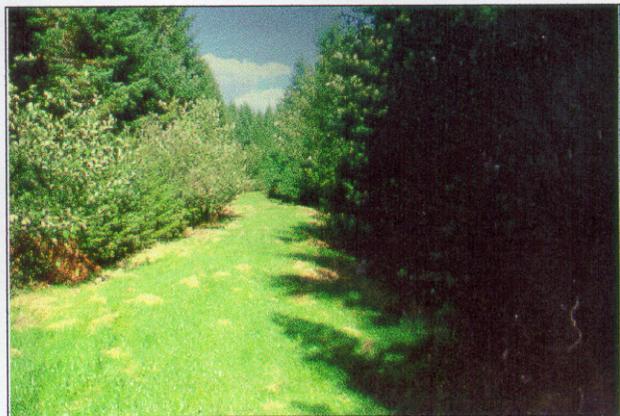
Before . . .

. . . After

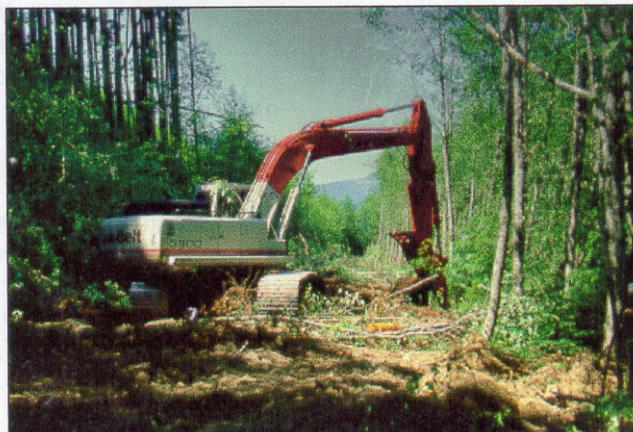
Road obliteration sometimes included excavation and recontouring of large volumes of road fill.

- All older roads will be obliterated, stream crossings restored and replanted in vegetation. A total of 105 miles of road will be obliterated.
- ▶ Areas identified as destabilized have had rock and debris removed.
